WRDC-TR-89-4055

COMPENDIUM OF FRACTOGRAPHIC DATA FOR COMPOSITE
MATERIALS

INTERIM REPORT
Covering 9-22-86 through 10-31-88

C. Hua
M. Yamashita
Boeing Advanced Systems
P.O. Box 3707
Seattle, WA 98124

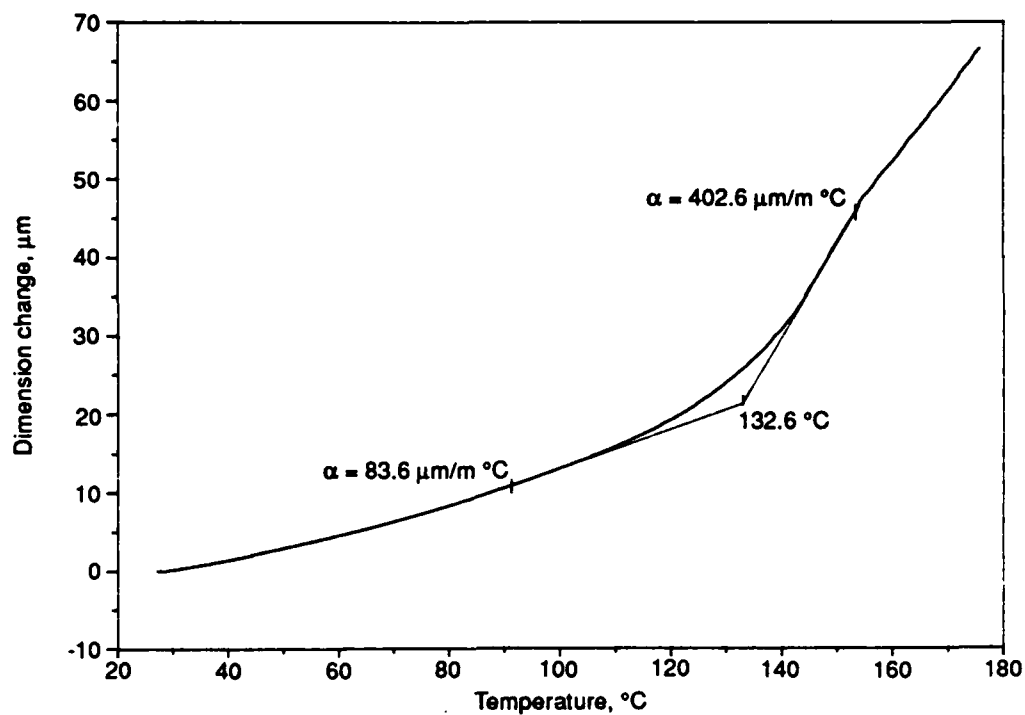
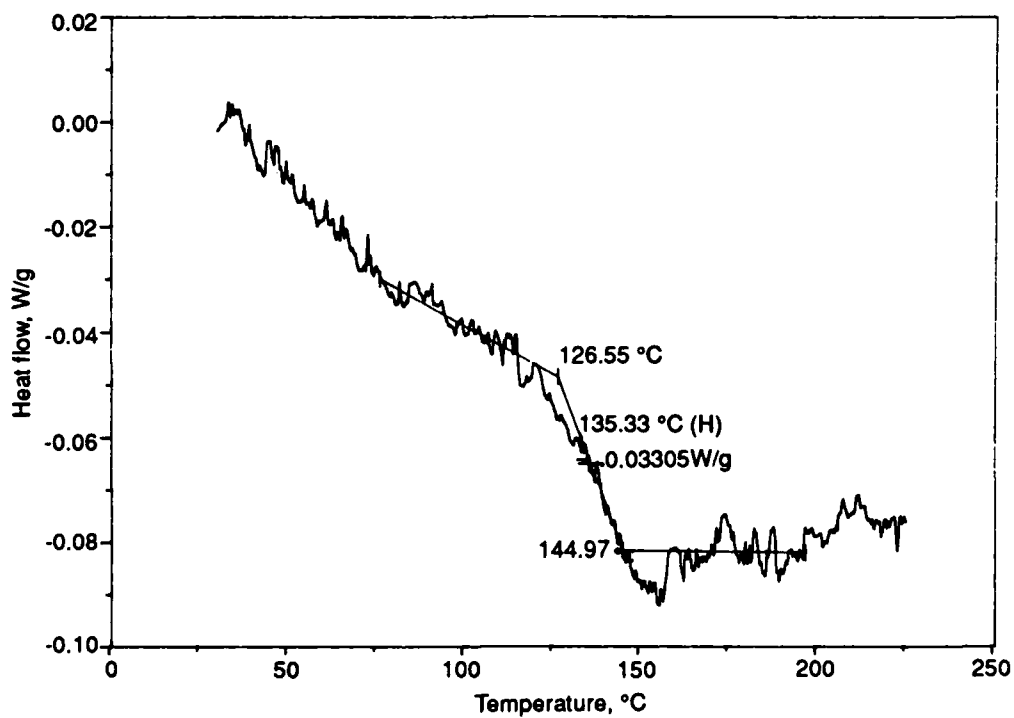
Figure 7.4-21. TMA and DSC Thermograms of Strut

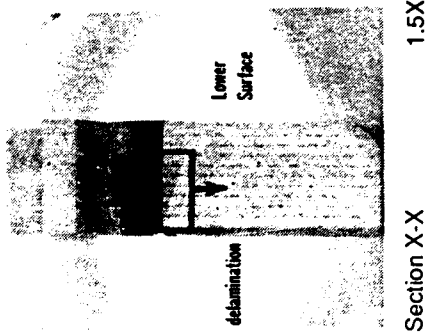
A metallographic section was taken through a bulged area (see Figs. 7.4-22 and 7.4-23), found adjacent to a bolthole, which was apparently the result of constraint by the bolt. This section revealed microbuckling of fibers in a crack-like formation extending from the delamination toward the lower surface. Fiber and matrix details were difficult to discern from the prepared section, but the overall condition of the laminate appeared to be good.

Figure 7.4-23. Macro photograph (A) and Photomicrograph (B) of Section X-X Taken Through the Bolthole and End. The segmented black lines outline a region of fiber microbuckling damage induced by the local restraint of the bolt on this side of the bolthole. The delamination and bolthole surfaces of this section are outlined by the segmented dashed lines.

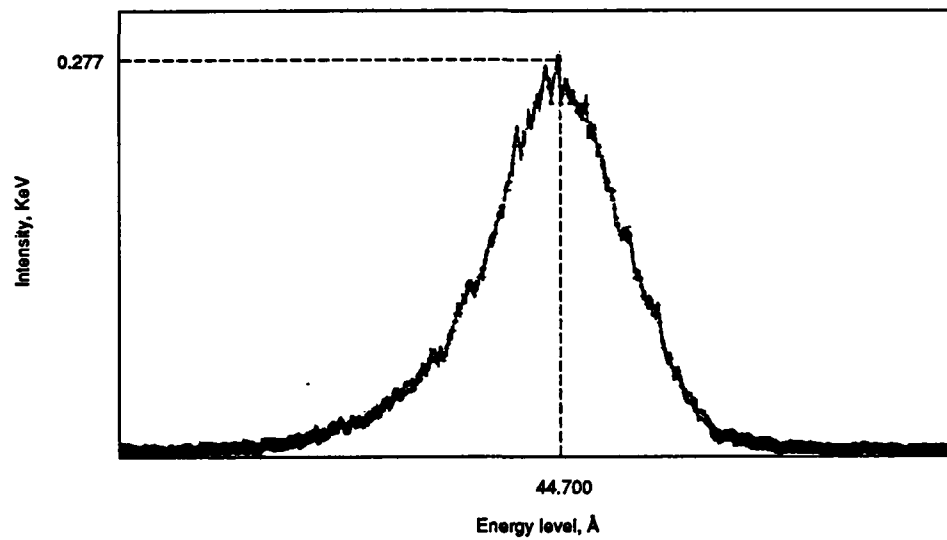
Wavelength Dispersive X-ray (WDX) Scan for Carbon K_{α}
